Re. Public Records Act Request

SUBJECT: ENGINEERING GEOLOGIC REVIEW OF TIMBER HARVESTING  
PLAN 1-06NTMP-023 HUM (Coleman/Lewis NTMP)

Regional Geologic Map  
 To Accompany  
 Engineering Geologic Review of  
 THP 1-06NTMP-023 HUM (Coleman/Lewis NTMP)

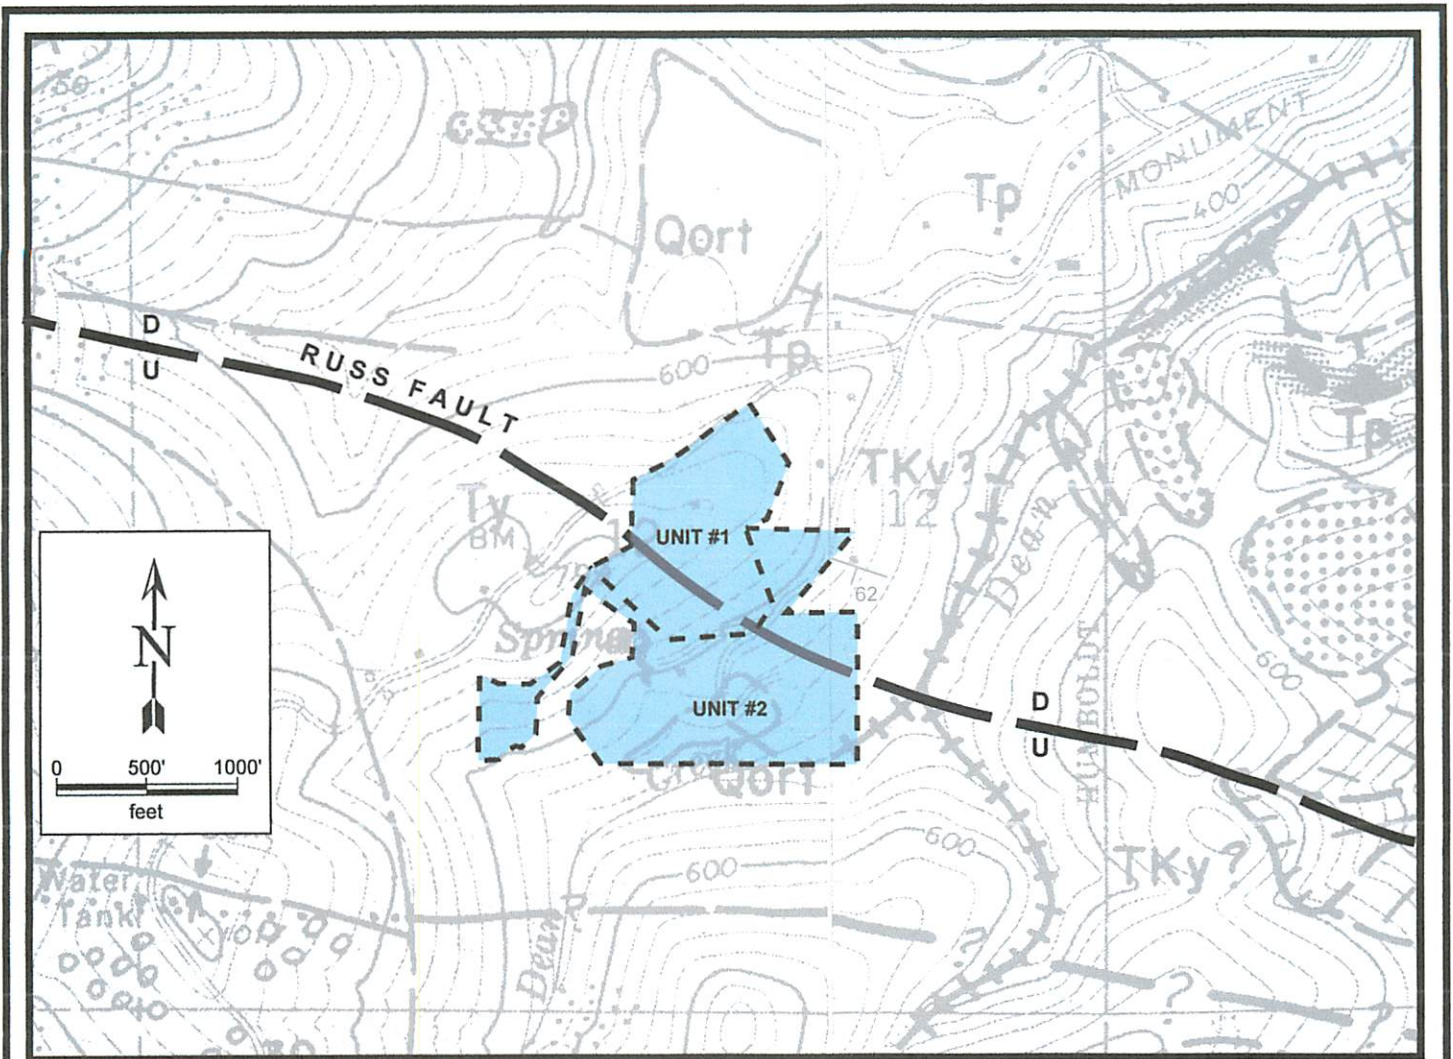
Figure:  
 1

Non-industrial timber management plan (NTMP) 1-06NTMP-023 HUM includes two adjacent harvest units proposed for moderate to steep slopes that face southeast (Figure 1). Geologic mapping by Ogle (1953) and Spittler (1984), show the proposed harvest area underlain by sedimentary rocks of the Yager terrane. These rocks dip steeply to the south and are described as highly sheared siltstone, sandstone, silty shale, mudstone, and conglomerate. Spittler (1984) also maps an older river terrace deposit (alluvial gravel) underlying the central portion of proposed harvest unit #2. McLaughlin and others (2000) have reinterpreted the geologic structure and distribution of rocks in this area and show the proposed harvest plan area to be bisected by the northwest trending Russ fault (Figure 1). The Russ fault is described as a reverse fault that dips steeply to the southwest and appears active at shallow depths (Kelsey and Carver, 1988; Jennings and Saucedo, 1994; and McLaughlin and others, 2000, p. 16). Within the plan area, McLaughlin and others (2000) show the Russ fault as the contact between the Yager terrane to the northeast and the Franciscan Complex coastal belt to the southwest. McLaughlin and others describe the Yager terrane rocks to be sheared and highly folded mudstone with minor interbeds of sandstone. They describe the
