# DEPARTMENT OF CONSERVATION

## CALIFORNIA GEOLOGICAL SURVEY

SUBJECT: ENGINEERING GEOLOGIC REVIEW OF TIMBER HARVESTING  
PLAN 1-06NTMP-023 HUM (Coleman/Lewis NTMP)

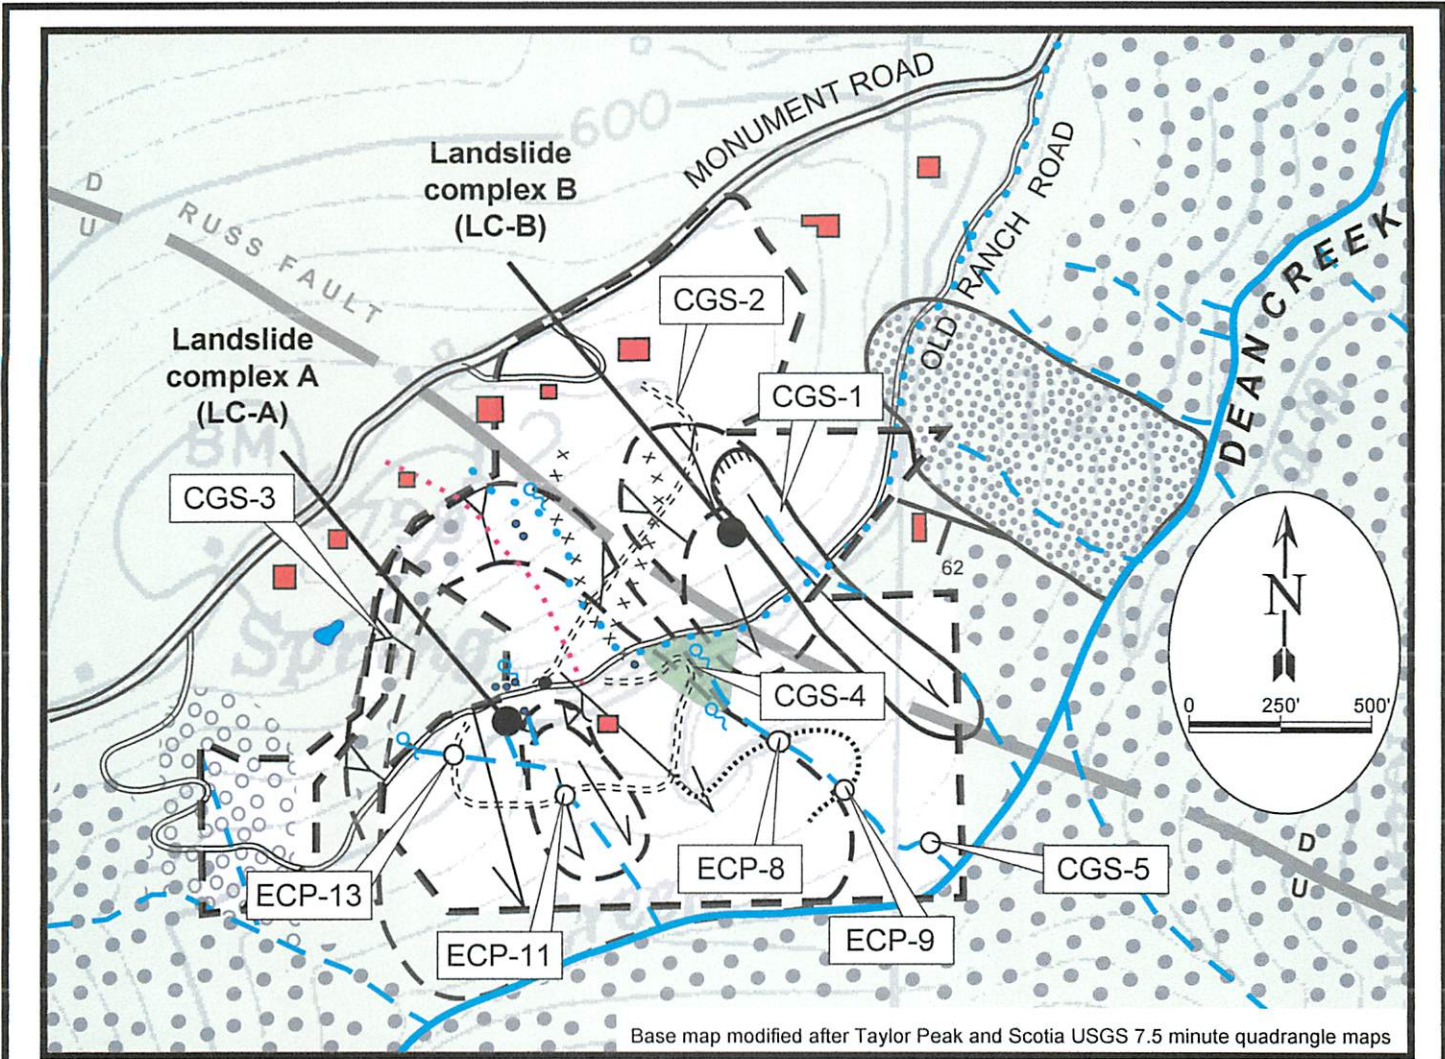
### Site Map

2. The City of Rio Dell maintains an easement for a culinary-use water supply pipeline along Old Ranch Road through the proposed plan area. Near the Lewis residence is a pumping station where the water is pumped upslope to residences along Monument Road. In general, the pipeline along Old Ranch Road lies exposed along the roadway fillslope of Old Ranch Road. There are numerous leaks and repairs in the pipeline, and several small debris slide scars in the fillslope are likely related to previous pipeline breaks and or leaks.

CGS-1 refers to the unstable area mapped by the RPF near the east boundary of the harvest unit along Old Ranch Road. Observations of this feature during the PHI and in the aerial photographs indicates that the active portion of this slide is significantly larger than mapped by the RPF and has been active for several decades. The most recent activity occurred during the winter of 2005/2006 and effectively blocks Old Ranch Road. It should also be noted that the recent activity appears to have broken the Rio Dell water supply pipe that has been repaired and now lies atop the landslide debris. As observed in the aerial photographs, the active earthflow appears to be a part of a larger translational/rotational rockslide that is dormant. For purposes of discussion, we identify this active earthflow and dormant rockslide as landslide complex B (LC-B). As observed during the PHI, the RPF appears to have accurately flagged the recently active portion of the earthflow. However, local geomorphic features (i.e., sharply defined down-dropped blocks within a steep bowl shaped depression) indicate that the most recently active area lies within a larger area of historical sliding.

CGS-2 refers to the proposed permanent road to be constructed through Unit #1 and which will provide a connection from Old Ranch Road to Monument Road. The grading required for this road will traverse across portions of both landslide complexes A and B (LC-A and LC-B), the Russ fault, two steep skid (currently ATV) trails, and the buried water supply pipeline. Given the residential development along Monument Road in conjunction with the existing geologic and hydrologic conditions underlying the proposed road alignment, controlling water on this road will be an important undertaking. More specifically, it appears likely that stormwater runoff from the residential areas, skid trails, and the roadway surface itself will need to be controlled to prevent concentrated discharge into the landslide complexes. Additionally, it appears likely that shallow groundwater tables associated either with the landslides and/or the Russ fault will be encountered and exposed by the grading. Typically, water seeping

CGS-3 refers to the steep (greater than 65 percent) arcuate debris slide slope along the northwest property boundary. Significant tree removal from this slope will expose the ground to more rainfall that has the potential to trigger debris slides. Such slide activity could adversely impact the downslope property owner (City of Rio Dell) and or convey sediment to the nearby watercourses.

CGS-4 refers to the area of disrupted ground downslope of Old Ranch Road and between LC-A and LC-B. The USGS 7.5 minute topographic map and 1954 aerial photographs show this area to be part of an old road and therefore, this area is interpreted to be the remains of a significant deposit of fill that has settled and been eroded over the years. The fill appears to have been placed in a shallow drainage swale at the upper reaches of the east watercourse, and water draining the Old Ranch Road and upper slope areas appears likely to concentrate in this area. Additionally, leaks of the Rio Dell water pipe also appear likely to flow toward this area. Portions of the fill deposit appear to have become saturated and evidence of piping was observed during the PHI. This fill deposit lies approximately 250 feet upstream from the watercourse crossing identified as ECP-8. That crossing appears to have trapped approximately 20 cubic yards of sediment, and it appears likely that much of that sediment was eroded from the upper fill deposit. The upper fill deposit appears to have been placed directly in a drainage swale and CGS is concerned that this mass of fill has a high potential for accelerated erosion and perhaps even mass wasting if greater amounts of water are discharged to this area. It should also be noted that runoff from the proposed new Unit #1 haul road may adversely impact this site.

ECP-8 is a Class III watercourse crossing that is probably an old Humboldt type crossing. Sediment transported from upstream has accumulated behind the fill prism and resembles an alluvial fan with braided channels. The surface of this accumulated sediment is at the level of the road surface. Currently, generally unconfined water flows across the accumulated sediment surface, across the road, and then onto the fillslope that has been eroded. It is estimated that 20 cubic yards of sediment is stored behind the crossing fill prism, and combined together, the crossing and stored fill probably comprise 50 or 60 cubic yards of sediment stored in this Class III channel. Dissimilar materials (e.g., rocks, concrete blocks) have been placed in the eroded fillslope channel over the years, but the erosion has apparently continued. As proposed in the NTMP, a rocked ford will be constructed at this location. CGS is concerned that the sediment stored behind the crossing has not been addressed and that the underlying old fill materials will remain a chronic source of sediment. Additionally, the unconfined nature of the streamflow across the accumulated sediment suggest a high potential for

ECP#9 is partially failed Class II watercourse crossing with a migrating headcut and enlarged ravine downstream. Currently the headcut is 5- to 6 feet high and locally undercut. The enlarged ravine is 15- to 20 feet wide. The channel gradient immediately upstream is relatively flat with a poorly defined channel. These observations suggest that sediment has accumulated behind the crossing. Consequently, it appears likely that if untreated, the headcut will migrate further upstream and through this deposit of accumulated sediment. Such erosion will likely deliver sediment to the Class I watercourse located approximately 400 feet downstream. As proposed in the NTMP, the fill is to be removed to allow the stream to re-establish a natural channel. CGS is concerned that a longitudinal profile through the crossing as a tool to guide the excavation has not been measured. During the PHI, the RPF and landowner expressed interest in rebuilding the crossing for future vehicle access. It should also be noted that runoff from the proposed new Unit #1 haul road may adversely impact this site.

CGS-5 is a diverted Class II watercourse that has eroded approximately 60 feet of old road and delivered sediment to the Class I watercourse located approximately 100 feet downstream. This diversion has eroded the roadway fillslope and formed a 4- to 5-foot headcut that is actively eroding the old road. Currently, the headcut is stalled at a small log that was buried in the fill. It will not be long before the log is eroded out of the fill and the headcutting will resume along the road. It is estimated that between 150 and 200 cubic yards of sediment would be eroded and delivered downstream as a result of the continued erosion of the road. Watercourse crossing diversions are explicitly addressed in the Forest Practice Rules under 923.4(n). CGS is concerned that this site has not been included as an erosion control point and no mitigation measures are proposed. It should also be noted that runoff from the proposed new Unit #1 haul road may adversely impact this site.

ECP#11 is a Class II watercourse crossing with a 9.5-foot vertical drop and much large wood at the outlet of a 24-inch culvert. This crossing is likely an old Humboldt type crossing and sediment has accumulated immediately upstream. As proposed in the plan, additional energy dissipaters are to be installed at the culvert outlet. CGS is concerned that no specific plan is provided to guide the LTO in the installation of an energy dissipater at this location.

ECP#13 is a proposed Class II watercourse crossing through a broadly depressed area. While a subtle channel does exist in this area, it is largely unconfined and appears much wider than the 18-inch culvert proposed in the plan. Additionally, adjacent areas of saturated ground suggest widely dispersed streamflow and/or a shallow groundwater table. CGS is concerned that draining this area into a single pipe may require channel excavations that lower the groundwater table and concentrate stream power at the outlet resulting in accelerated erosion. Additionally, the road constructed through this area will require an approximately 100-foot long, 5- to 8-foot high fill prism that will

CGS-1 – As discussed during the PHI, a 25-foot equipment exclusion zone (EEZ) will be flagged around the larger area of historic landsliding as indicated by the geomorphic features. Additionally, the flag line shall be accurately plotted on the NTMP maps. Harvesting within the flagged landslide area shall be restricted to single-tree selection to the extent that the ground is protected by no less than 50 percent overstory canopy. The updated maps shall be submitted to CGS a minimum of five days prior to Second Review to allow CGS the opportunity to evaluate the new flagging and mapping on the ground.

CGS-2 – Because of the presence of LC-B and the importance of controlling the drainage along the proposed Unit#1 road, a more detailed plan of the proposed construction is required. This plan shall be prepared at a scale that will depict the

CGS-3 – Because of the potential for debris sliding and related offsite impacts, it is recommended that group selection not occur on these steep slopes. It is our understanding this recommendation is consistent with the Threatened and Impaired rules set forth in the Forest Practice Rules.

CGS-4 – It is recommended that this area be flagged and delineated on the NTMP maps as an area of environmental sensitivity in which grading, harvesting, and/or drainage modifications shall be carefully planned and explicitly described. This site characterization and any proposed plans shall be submitted for agency review minimum of thirty days prior to any planned operations to allow CGS the opportunity to evaluate the plan on the ground.

ECP-8 – It is recommended that the full extent of the crossing fill and stored sediment be depicted in a sketch that includes the proposed rocked-ford design. Moreover, the potential for additional sediment accumulation behind the crossing and subsequent stream diversion shall also be discussed. This site characterization and the proposed plan shall be submitted to CGS a minimum of five days prior to Second Review to allow CGS the opportunity to evaluate the plan on the ground.

ECP#9 – Based on the PHI discussions, this crossing may be reconstructed rather than removed. In either case, it is recommended that the full extent of the crossing fill, stored sediment, migrating headcut, and enlarged gully be depicted in a sketch that includes the preferred design. If however, the crossing is to be removed, the characterization shall include a longitudinal profile with which to guide the proposed fill and accumulated sediment excavation. The longitudinal profile shall extend upstream beyond the wedge of stored sediment and shall extend downstream beyond the fillslope and recently enlarged gully. This site characterization and the proposed plan shall be submitted to CGS a minimum of five days prior to Second Review to allow CGS the opportunity to evaluate the plan on the ground.

CGS-5 – It is recommended that this site be included in the NTMP as an erosion control point (ECP) and that an appropriate characterization be conducted and a mitigation plan be developed.

ECP#11 – It is recommended that that the full extent of the crossing fill and stored sediment be depicted in a sketch that includes the proposed design for energy dissipaters. A longitudinal profile through the crossing would likely assist in the design of an energy dissipater at this location.

ECP#13 – It is recommended that a more detailed description of the channel and surrounding wet area be discussed within the context of draining this area with an 18-inch culvert. Such a discussion should include a scaled sketch-map and the precise location of the culvert to be installed shall be flagged on the ground. This site characterization and the proposed plan shall be submitted to CGS a minimum of five days prior to Second Review to allow CGS the opportunity to evaluate the plan on the ground.

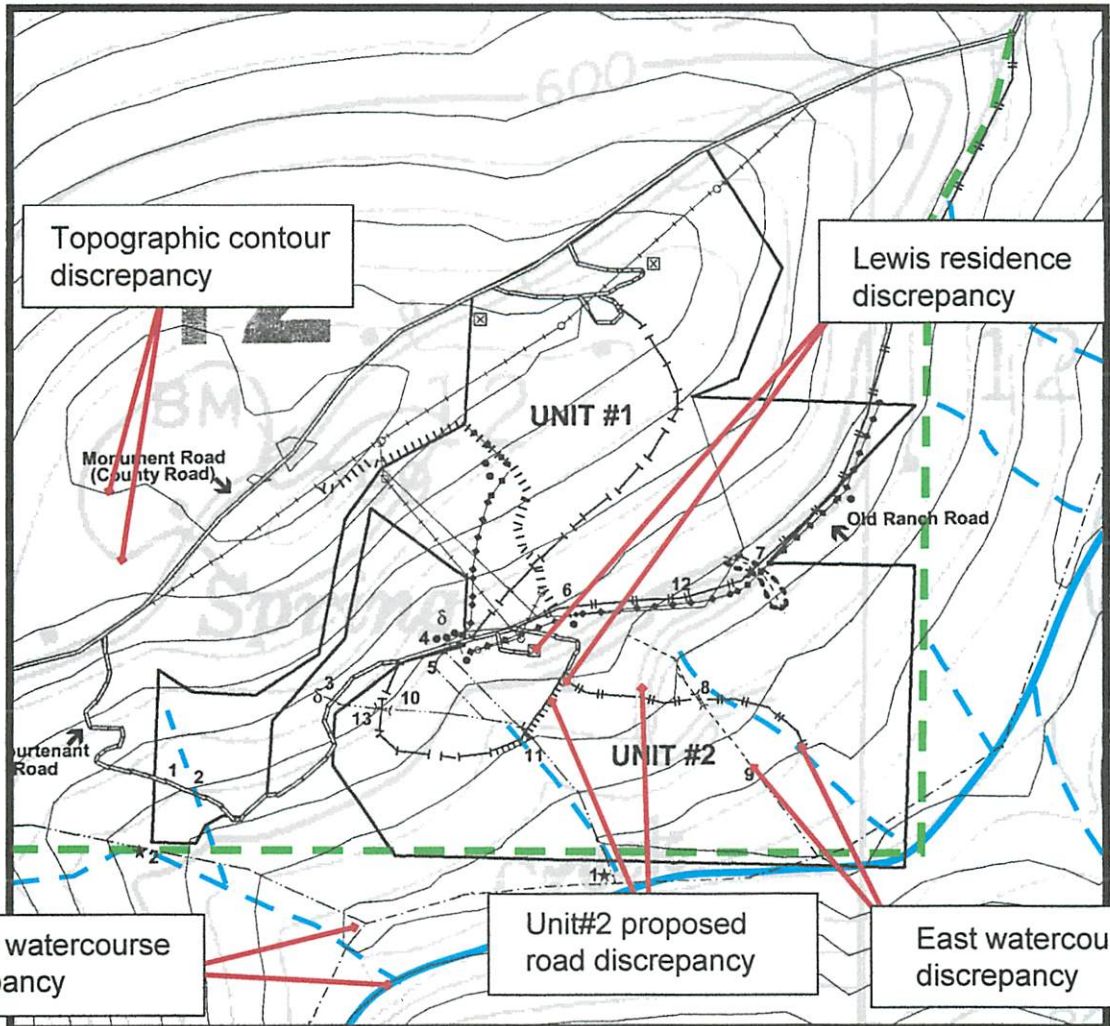
Comparison of NTMP Map to USGS Base Map  
 To Accompany  
 Engineering Geologic Review of  
 THP 1-06NTMP-023 HUM (Coleman/Lewis NTMP)

1. A comparison of the THP map (THP page 21) and a 2005 aerial orthophotograph revealed some discrepancies with regard to the number of private residences in the area as well as the location of some of the existing and proposed roads (Figure 3). Figure 3 was developed by overlaying the THP map onto the USGS 7.5 minute topographic map and a 2005 orthophotograph using Monument and Old Ranch roads as the common features. Additionally, plan maps from Scotia Pacific LLC (2002) showing the watercourses are also plotted on Figure 3. As shown on Figure 3, contour lines, watercourses, residential structures, and the other roads depicted on the THP map do not align well. In particular, the Lewis residence, the proposed Unit#2 road, and the east watercourse appear to be misaligned in the range of 150 feet. From a practical standpoint, the THP map appeared to be sufficiently accurate during the PHI and would probably be sufficient to guide the harvest operations. However, in light of the landslide mapping described above and the proposed operations, significant problems arise when trying to understand the spatial relations (i.e., distances) between the landslides, springs, watercourses, residences, roads, and proposed roads. Without a more accurate depiction of the spatial relationships between the geomorphology and anthropogenic improvements, it is not possible to

fully evaluate the potential impacts that may occur in response to the proposed harvest and road construction activities.

1. The RPF shall compare and contrast their mapping with the USGS and SCOPAC mapping in conjunction with the mapping provided herewith. The RPF is also encouraged to examine the aerial photographs available for review at the California Geological Survey office in Eureka. Particular attention shall be paid to the location of the Lewis residence, the east watercourse, and the alignment of the proposed Unit #2 road. Additionally, the alignment of the western extent of Old Ranch Road from the Lewis residence to Monument Road shall be verified. Upon completion of the comparison, either the NTMP maps shall be updated or a discussion explaining the mapping discrepancies and justifying the accuracy of the existing NTMP shall be provided.

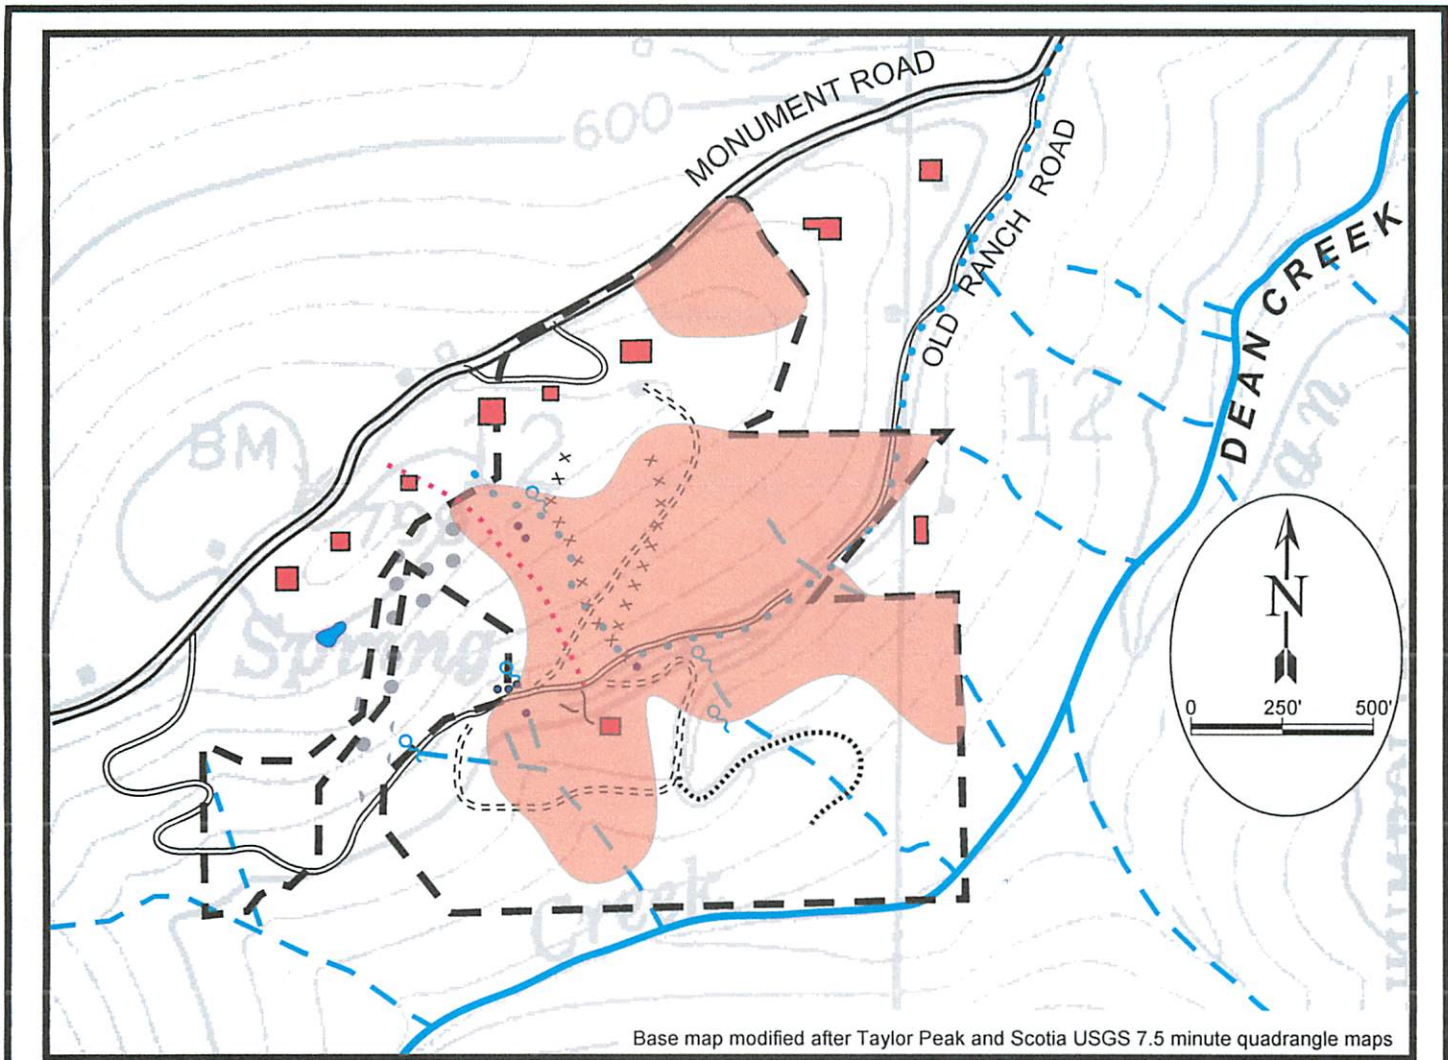
Harvesting Restrictions Map  
To Accompany  
Engineering Geologic Review of  
THP 1-06NTMP-023 HUM (Coleman/Lewis NTMP)

3. There are several areas within the plan area that appear vulnerable to environmental impacts associated with timber harvest operations. This vulnerability is primarily related to either road drainage or concentration of water (either rainfall or streamflow) onto sensitive areas. CGS is concerned that group selection type harvesting (i.e., 2.5-acre clearcuts) in these sensitive areas has the potential to cause significant adverse environmental impacts. The sensitive areas are described below and are also depicted on Figure 4.

3. It is recommended that the sensitive areas delineated in Figure 4 be excluded from group selection type harvesting unless the area is characterized in detail by a geologist licensed in the State of California. The site characterization of these areas shall be submitted to CGS for review and concurrence a minimum of 30 days prior to the commencement of operations in those areas.
